Manhole Inspection Summary

Manhole # S33EE_060MH

Insp Date: **3/23/07 12:15 PM**

Location Address: **1212 PARK AVE**

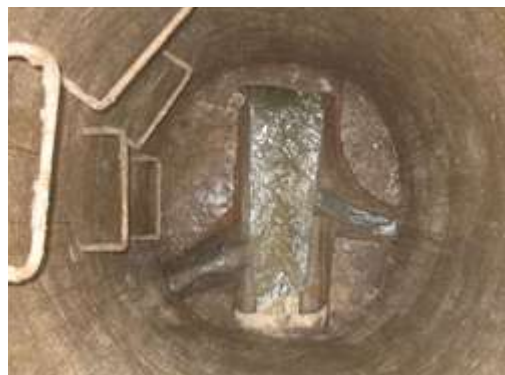
Top View

Bench debris.

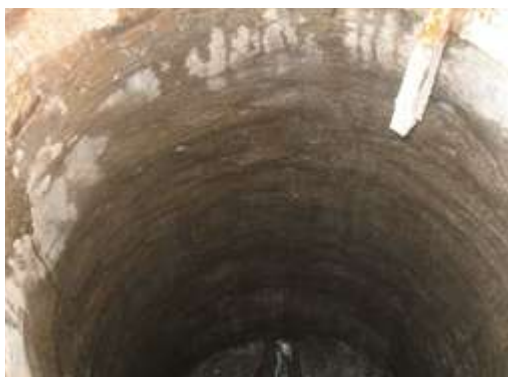
Defect

☒ **Leaks**

Infiltration: ☐ None ☒ **Joint** ☐ Cracks ☐ Mortar ☐ Roots ☒ **Wall**

Infiltration: ☐ None ☐ Joint ☐ Cracks ☐ Mortar ☐ Roots ☒ **Wall**

Frame leaks. Adjustment and Corbel infiltration.

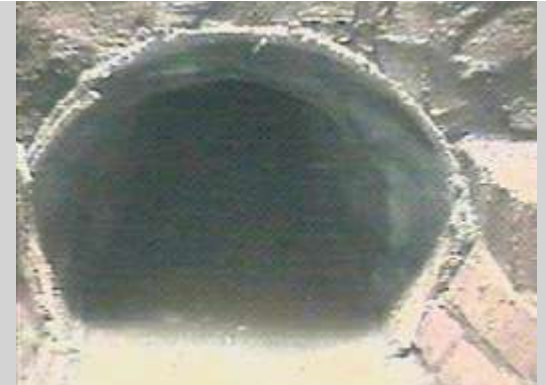
18 in. Circular Gravity Sewer Pipe Out @ 12 O'Clock

Invert Depth: **12.30** (ft.) Flow Characteristics: **Fast**

Infiltration: **None** Pipe Seal Cond: **Unknown**

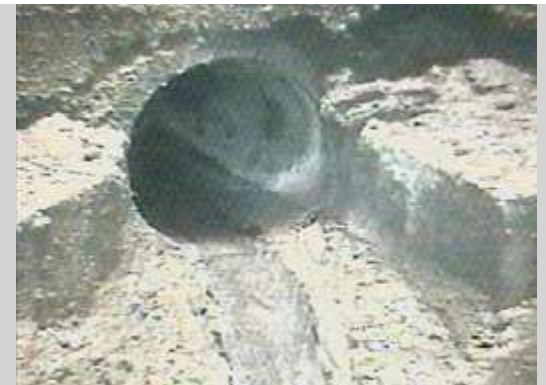
8 in. Circular Gravity Sewer Pipe In @ 3 O'Clock

Invert Depth: **11.52** (ft.) Flow Characteristics: **Slow**

Infiltration: **None** Pipe Seal Cond: **Unknown**

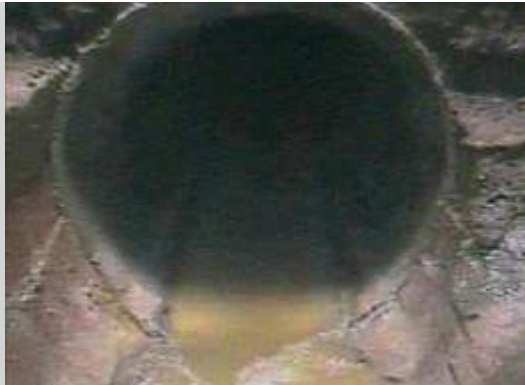
18 in. Circular Gravity Sewer

Invert Depth: **12.13** (ft.) Flow Characteristics: **Fast**

Infiltration: **None** Pipe Seal Cond: **Unknown**

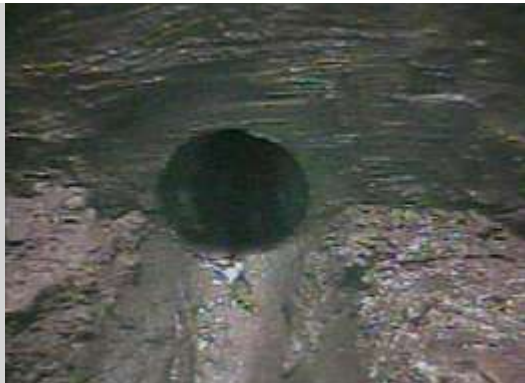
6 in. Circular Gravity Sewer

Invert Depth: **11.31** (ft.) Flow Characteristics: **Slow**

Infiltration: **None** Pipe Seal Cond: **Unknown**
